**FINAL REPORT
MARCH 2001**

REPORT NO. 00-02

**S-280 Shelter Tie-down Kit
TP-94-01, Transportability Testing Procedures**

**VALIDATION ENGINEERING DIVISION
MCALESTER, OKLAHOMA 74501-9053**

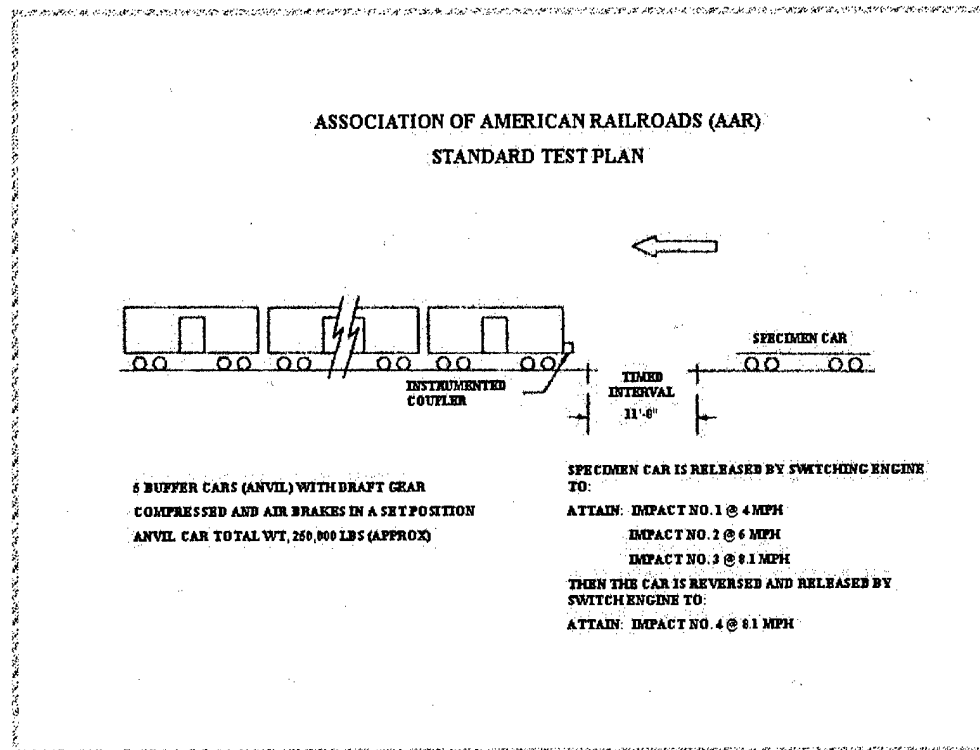
Figure 1. Rail Impact Sketch

A. RAIL IMPACT TEST METHOD. The vehicles were loaded and secured to a conventional friction draft gear flatcar. Equipment needed to perform the test included the specimen (hammer) car, four empty railroad cars connected together to serve as the anvil, and a railroad locomotive. The anvil cars were positioned on a level section of track with air and hand brakes set and with draft gears compressed. The locomotive unit pushed the specimen car toward the anvil at a predetermined speed, then disconnected from the specimen car approximately 50 yards away from the anvil cars allowing the specimen car to roll freely along the track until it struck the anvil. This constituted an impact. Impacting was accomplished at speeds of 4, 6, and 8.1 mph in one direction and at a speed of 8.1 mph in the reverse direction. The 4 and 6 mph impact speeds were approximate; the 8.1 mph is a minimum. Impact speeds were determined by using an electronic counter to measure the time for the specimen car to traverse an 11-foot distance immediately prior to contact with the anvil cars (see Figure 1).

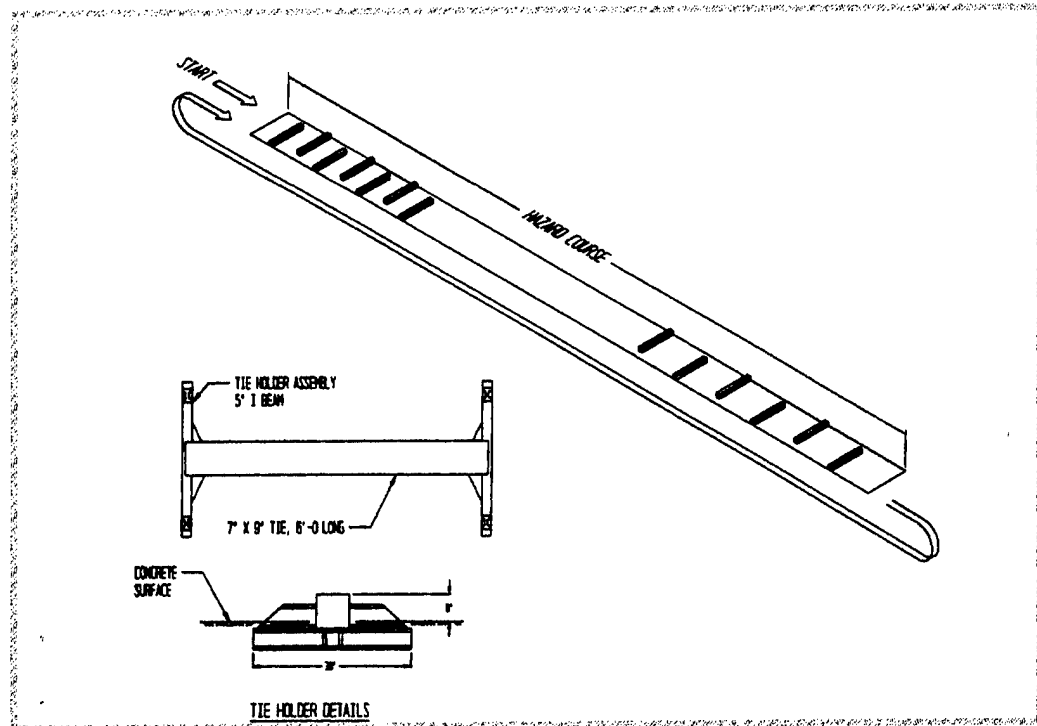
Figure 2. Hazard Course Sketch

B. HAZARD COURSE. The vehicles with the S-280 shelter and tie-down kit were transported over the 200-foot-long segment of concrete-paved road consisting of two series of railroad ties projecting 6 inches above the level of the road surface. The hazard course was traversed two times (see Figure 2) prior to the Road Trip and two times following the completion of the Road Trip.

1. The first series of ties are spaced on 8-foot centers and alternately positioned on opposite sides of the road centerline for a distance of 50 feet.
2. Following the first series of ties, a paved roadway of 75 feet separates the first and second series of railroad ties.
3. The second series of ties are spaced on 10-foot centers and alternately positioned on opposite sides of the road centerline for a distance of 50 feet.
4. The test load is driven across the hazard course at speeds that would produce the most violent vertical and side-to-side rolling reaction obtainable in traversing the hazard course (approximately 5 mph).

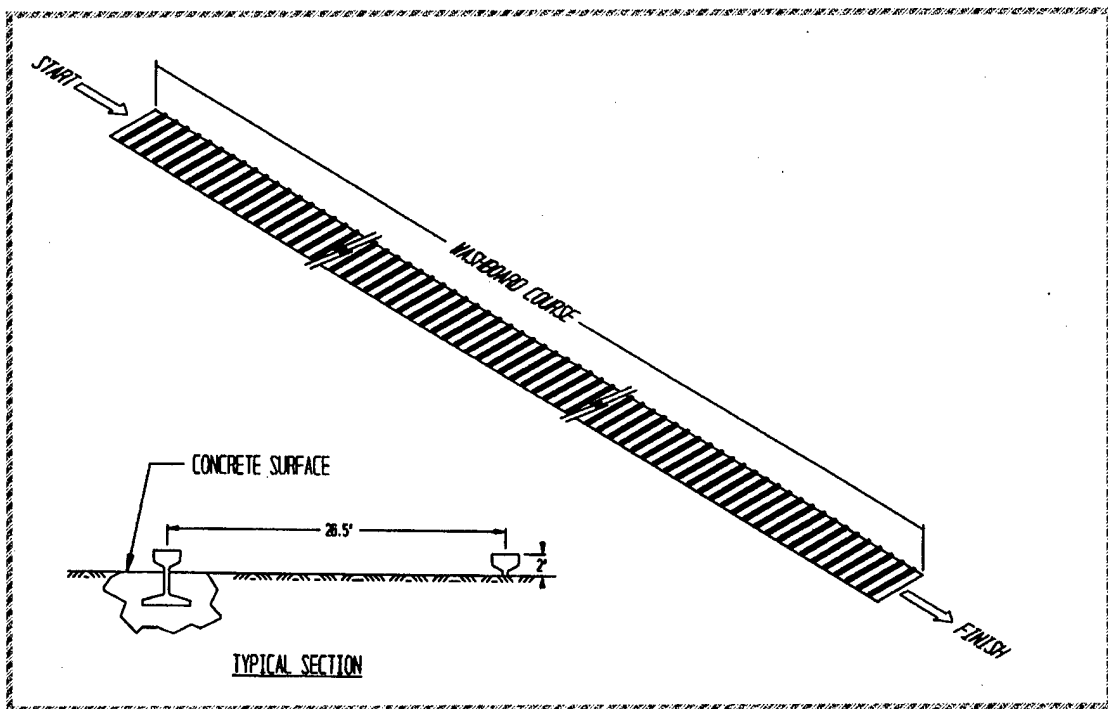
Figure 3. Washboard Course Sketch

E. WASHBOARD COURSE. The vehicles with the S-280 shelter and tie-down kit were driven over the washboard course at a speed that produced the most violent response in the vehicles.

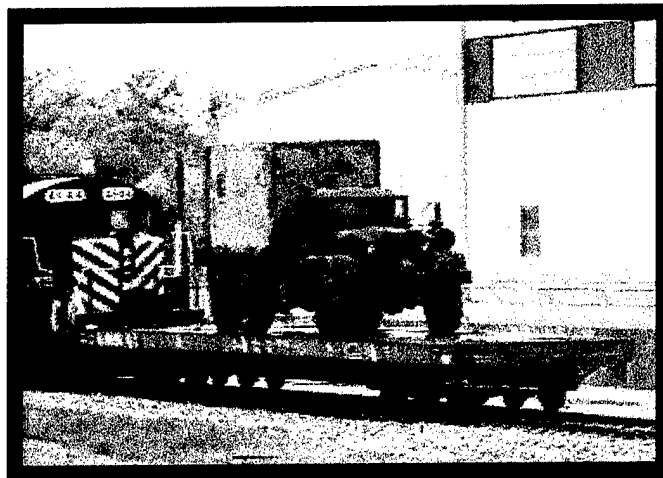
Rail impact test of S-280 Shelter with Tie-down Kit

Remarks: No damage or failures occurred with the S-280 Shelter, S-280 Shelter Tie-down Kit or the vehicle.

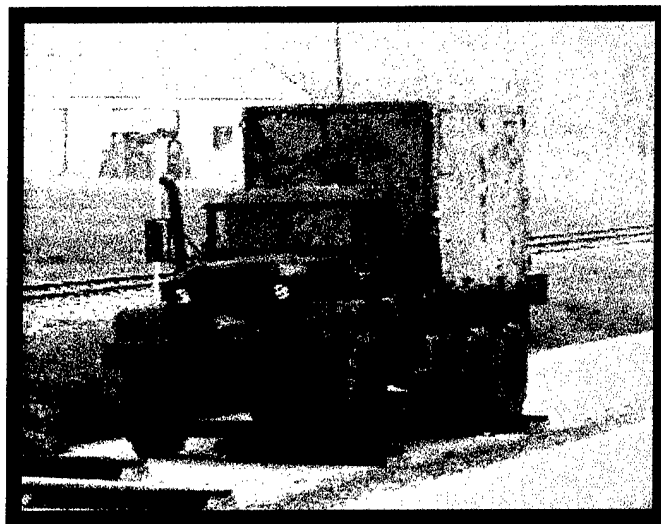
Hazard course test of S-280 Shelter with Tie-down Kit

Remarks: The tie-down anchor on the front passenger side came out during transport over the road course. The vibration of the shelter rings against the tie-down anchors caused the chain anchors to disengage. The overall shelter movement was 0.5 inches toward the passenger side of the vehicle. The remaining three tie-downs did not disengage during testing. The tie-down was reattached and testing continued.

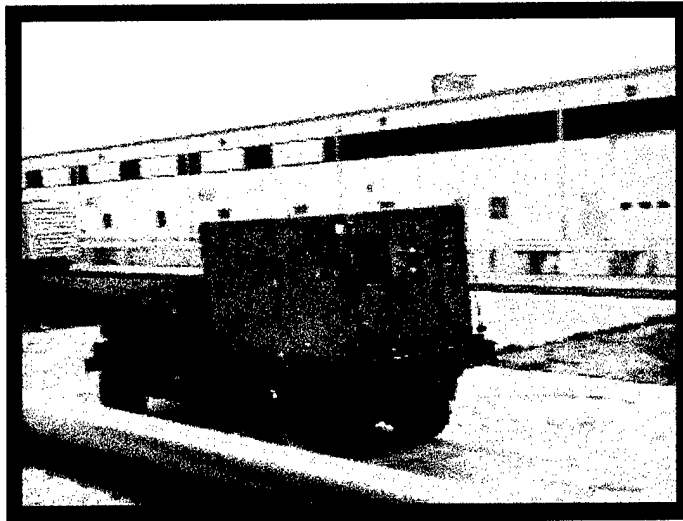
D. PANIC STOPS: No damage or failures occurred with the S-280 Shelter, S-280 Shelter Tie-down Kit or the vehicle.

Panic stop with S-280 Shelter and Tie-down Kit

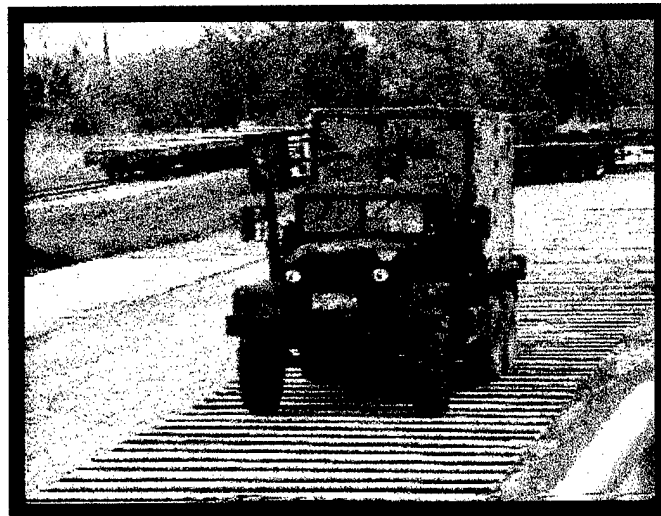
E. WASHBOARD: No damage or failures occurred with the S-280 Shelter, S-280 Shelter Tie-down Kit or the vehicle.

Washboard course test with S-280 Shelter and Tie-down Kit

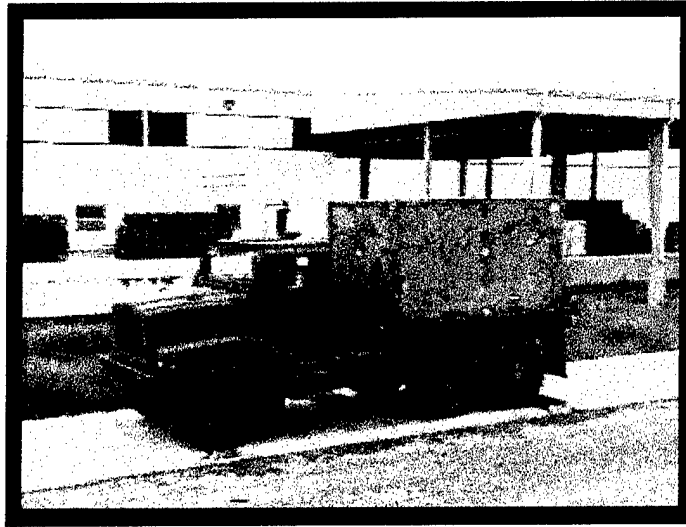
Hazard course testing of S-280 Shelter with Tie-down Kit

Remarks: No damage or failures occurred with the S-280 Shelter, S-280 Shelter Tie-down Kit or the vehicle.

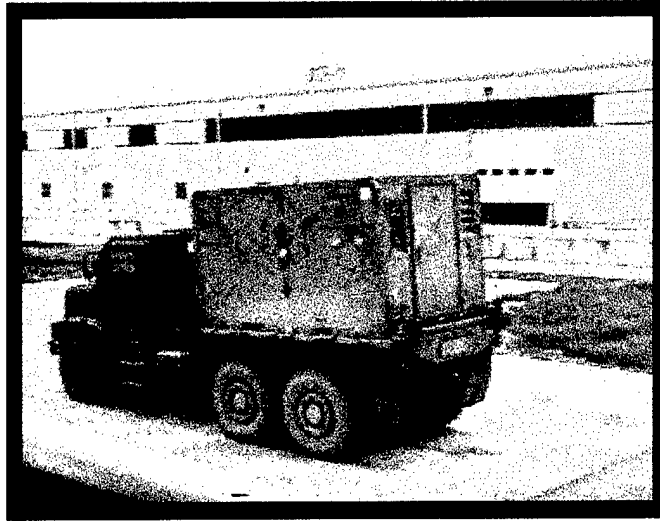
D. PANIC STOPS: No damage or failures occurred with the S-280 Shelter, S-280 Shelter Tie-down Kit or the vehicle.

Panic stop testing of S-280 Shelter with Tie-down Kit

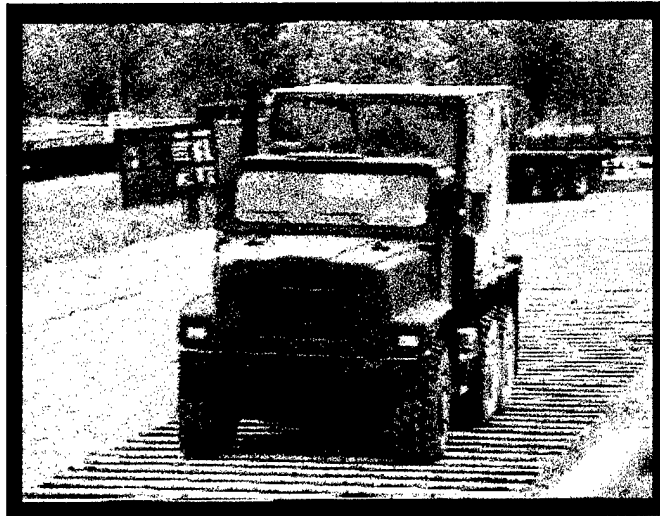
E. WASHBOARD: No damage or failures occurred with the S-280 Shelter, S-280 Shelter Tie-down Kit or the vehicle.

Washboard course testing of S-280 Shelter with Tie-down Kit

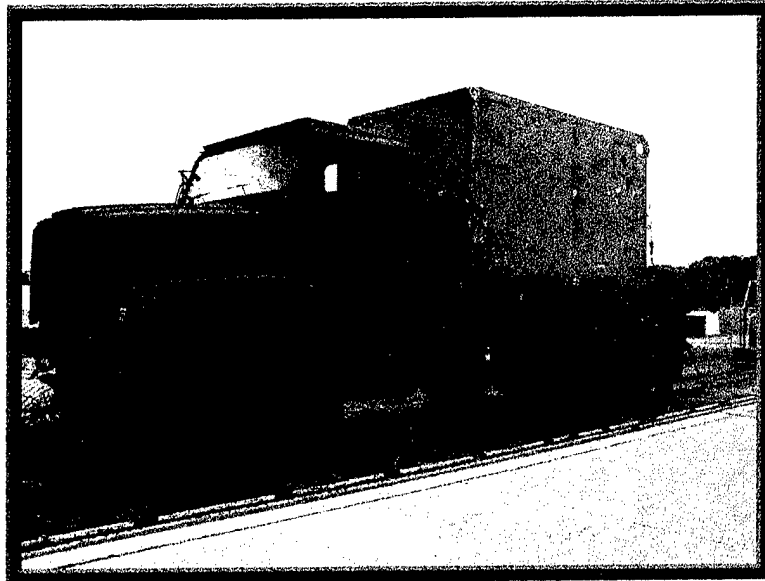
Rail impact testing of S-280 Shelter with Tie-down Kit

Remarks: No damage or failures occurred with the S-280 Shelter, S-280 Shelter Tie-down Kit or the vehicle.

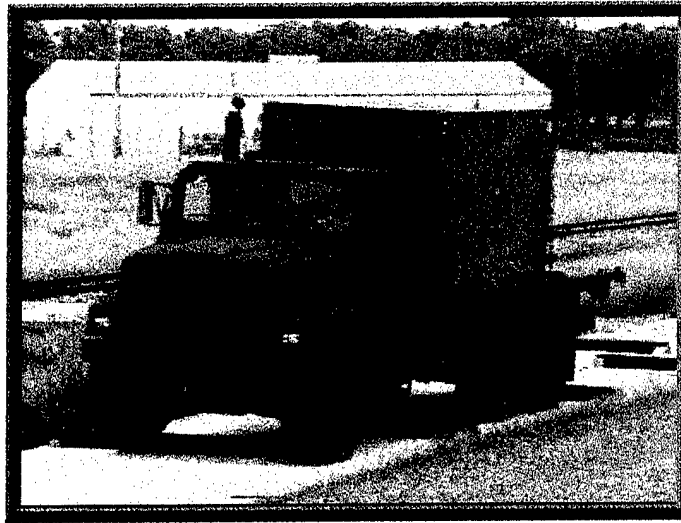
Hazard course testing of S-280 Shelter with Tie-down Kit

Remarks: Following completion of Pass #2 on 11 May 2000 the turbocharger on the vehicle failed. Testing was stopped and the vehicle was repaired. The shelter and kit were removed from the vehicle during the repair. Testing resumed on 24 May 2000.

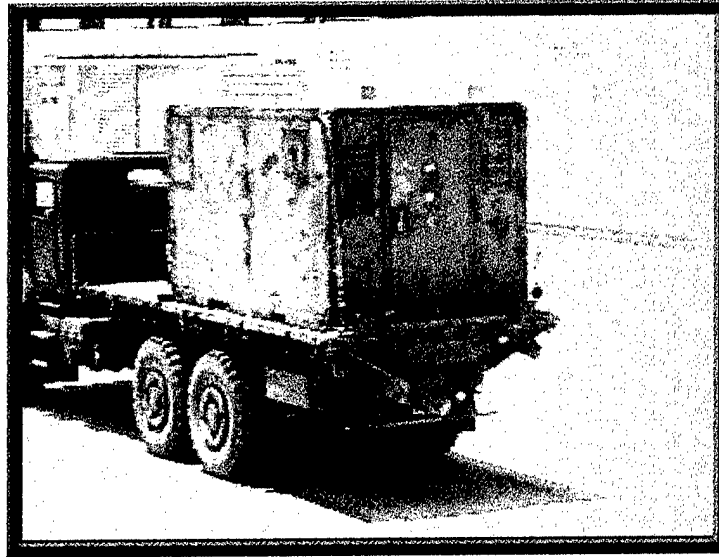
D. PANIC STOPS: No damage or failures occurred with the S-280 Shelter, S-280 Shelter Tie-down Kit or the vehicle.

Panic stop testing of S-280 Shelter with Tie-down Kit

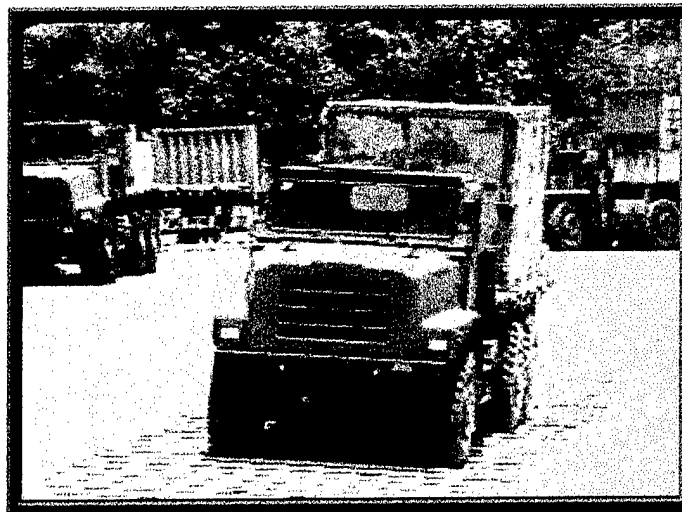
E. WASHBOARD: No damage or failures occurred with the S-280 Shelter, S-280 Shelter Tie-down Kit or the vehicle.

Washboard course testing of S-280 Shelter with Tie-down Kit
